AT13-018

September 10, 2013

2013 – 2014 JX/QX60; JUDDER DURING LIGHT ACCELERATION

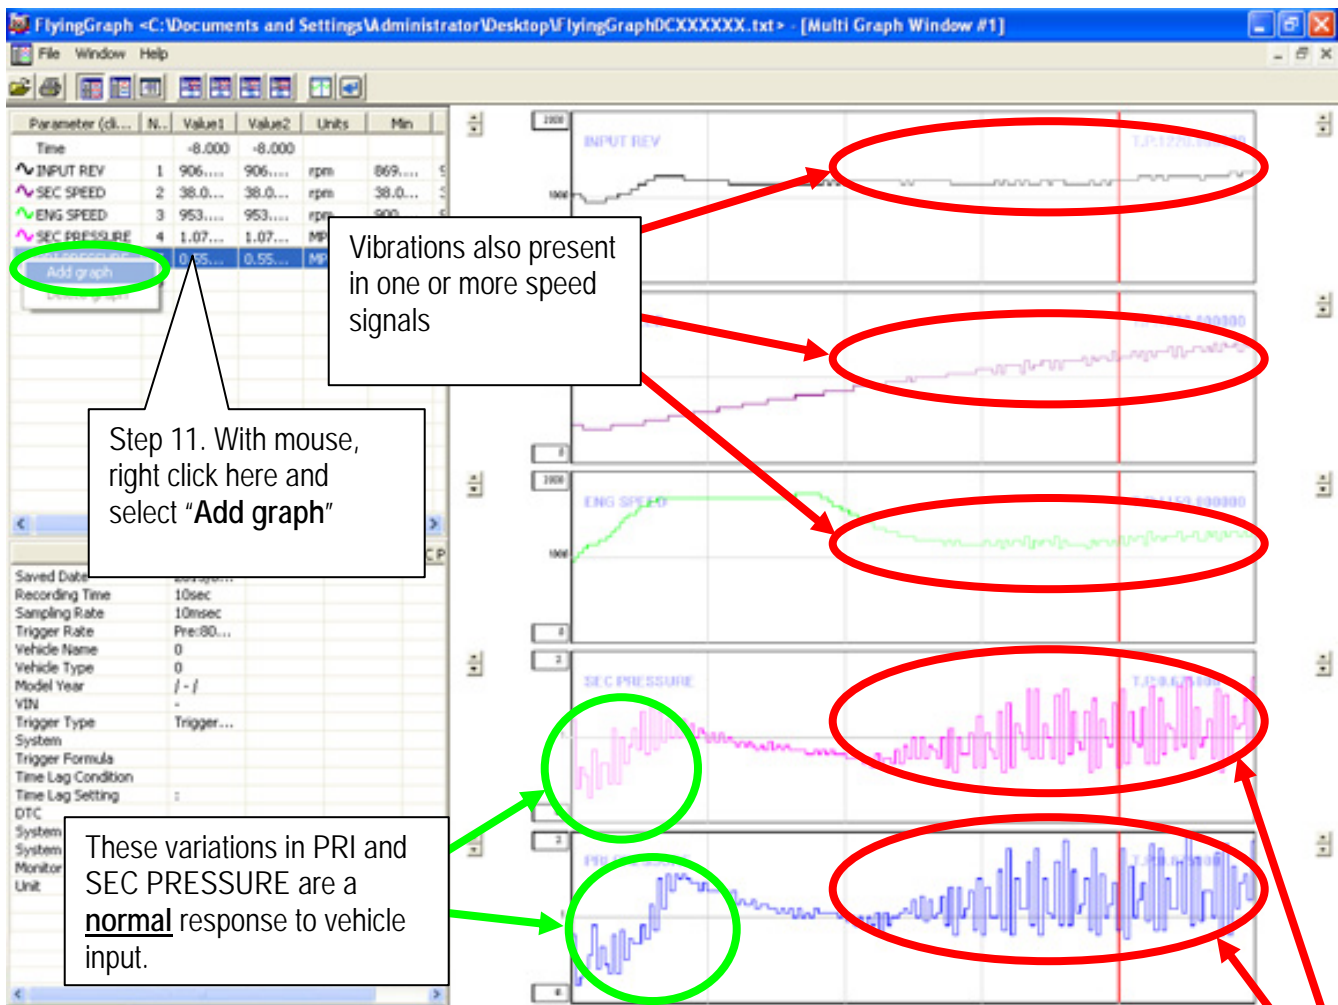
Figure 13

13. During data review, if your data shows a Repetitive Pressure Vibration in either **PRI PRESSURE** or **SEC PRESSURE**, and also shows an irregular (non-smooth) line in one or more speed signals (**ENG SPEED**, **INPUT REV**, **SEC SPEED**) as indicated in Figure 13, replace the CVT to resolve (Figure 13 shows Repetitive Pressure Vibrations circled in red).

- **Do not** replace the torque converter assembly if the data review shows Repetitive Pressure Vibration as described above.
- If a judder is present and the recorded data review shows that the data lines are smooth with no oscillations as shown in Figure 14 above refer to Torque Converter Replacement on page 17.

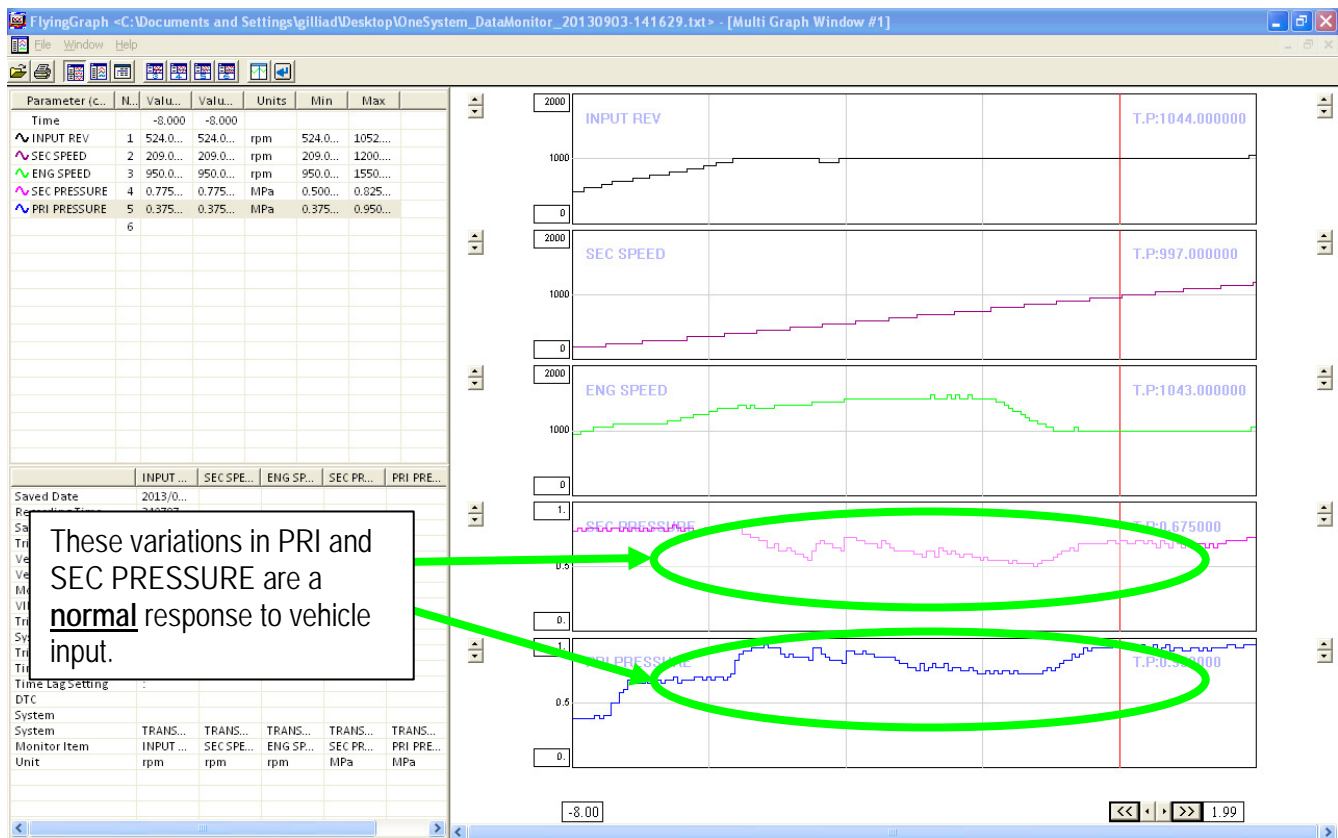
NOTE: Figure 14 shows INPUT REV, SEC SPEED, ENG SPEED, PRI PRESSURE and SEC PRESSURE from a vehicle that does not have a judder present.
